# PMDC GEOLOGICAL AND GEOHAZARD ASSESSMENT AT TAGBANAOS AREA, BARANGAY UPPER ULIP

**COMPOSTELA VALLEY PROVINCE, Philippines** – The Philippine Mining Development Corporation (PMDC) conducted a geological and geohazard assessment at Tagbanaos Area, Barangay Upper Ulip, Monkayo, Compostela Valley Province last May 29-30, 2018. As part of the Diwalawal Mineral Reservation Area (DMRA), PMDC represented by junior geologist, *Ms. Abigail I. Abenoja*, Mines and Geosciences Bureau (MGB) Region XI geologists, *Ms. Beverly Mae M. Brebante* (Supervising Geologist), *Ms. Lady Rose G. Tablo* (Geologist), *Ms. Marie Anne E. Garcia* (Geologist) and City Environment and Natural Resources Office (CENRO) - Monkayo representative, *Ms. Rheycalyn Lugtu* (Geologist) mapped and assessed the area for potential development purposes in the future.

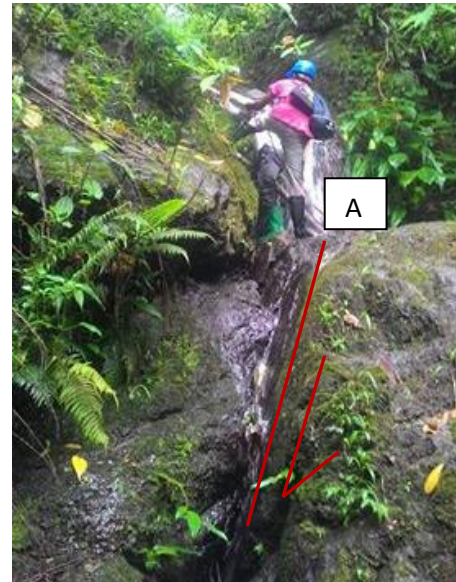
As per the geohazard assessment of the Team, the Tagbanaos Area is said to be moderately to highly susceptible to landslide due to its steep and rugged terrain as shown in *Figures 1 and 2*. However, the area is dominantly volcanoclastic and porphyritic andesite which are highly competent rocks.

In addition, the outcrops were classified as moderately to highly jointed volcanoclastics showing the dominant trend (e.g. strike and dip direction) of the bedding plane as illustrated in *Figure 3*. While *Figure 1* showed rocks of the same lithology displaying high angle elevation crossed cut by an inferred fault – physiographically manifested by high angle falls – which is now being followed as the course of the tributary upstream.

Figure 1. PMDC junior geologist *Ms. Abenoja* and one PMDC geologic aid assessed and mapped the area following ridges and tributaries with steep slopes.

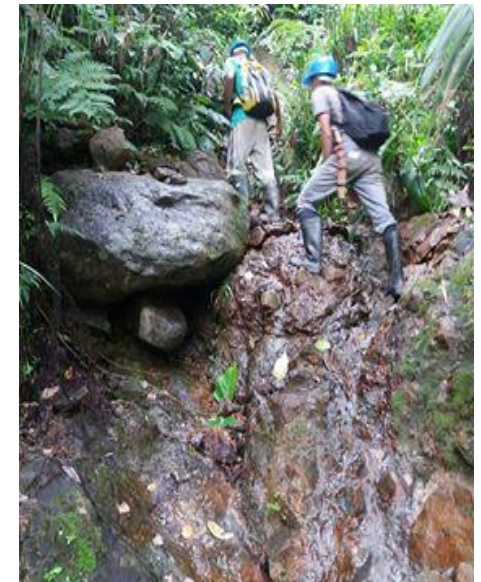
Figure 2. Two PMDC geologic aids guiding and assisting MGB XI geologists while displaying an outcrop showing the clast size of the volcanoclastic rock

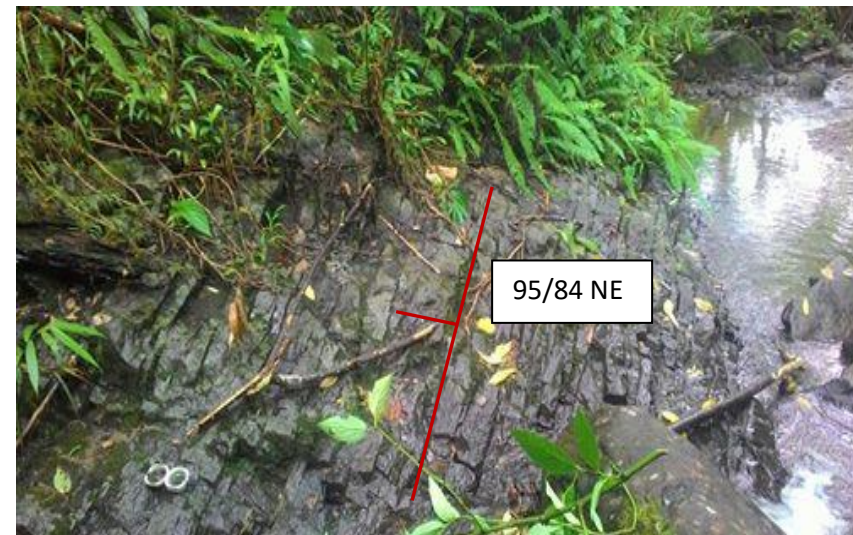
Figure 3. (Looking Southwest) Moderately to highly jointed outcrop showing the dominant trend (e.g. strike& dip direction) of the bedding plane.

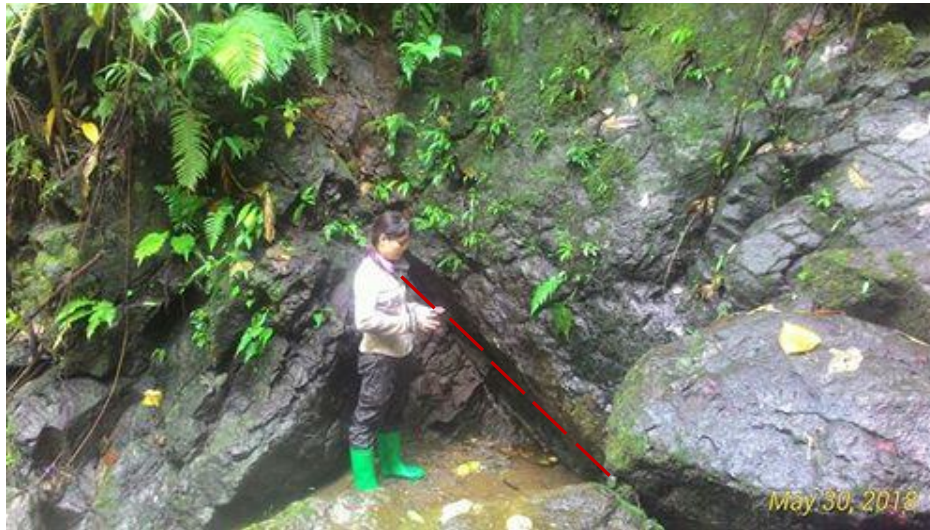
Figure 4. (Looking North) Fault in the volcanic rock having an orientation of 133/50 NE (MGB XI, 2018)

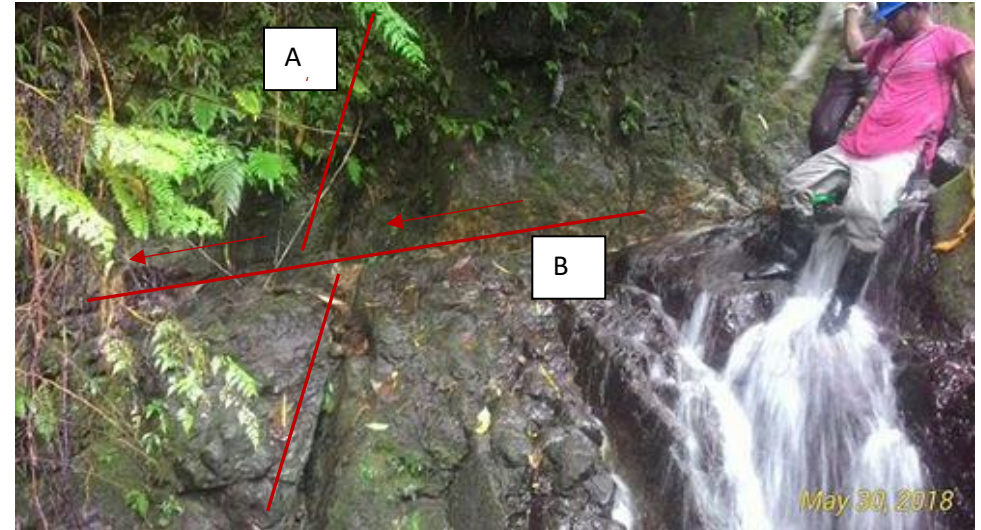
Figure 5. (Looking North) Fault (A) with 5cm quartz-calcite vein having an orientation of 345/85 SW cut by a gougy right strike-slip fault (B) with an orientation of 120/88 NE on the altered andesite porphyry (MGB XI, 2018)

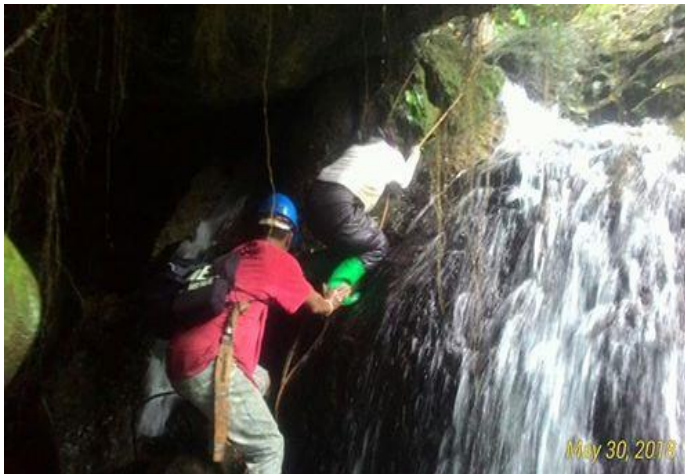
Figure 6. Creek being traversed by the Team during assessment

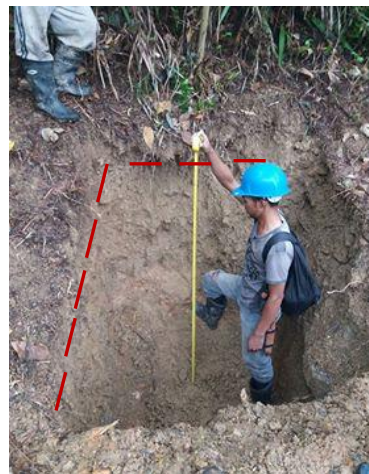
Figure 7. A) Red lines showing dimensions: Width- 1.4m, Length- 1.7m, Height- 1.7m  
B) From top to 1.2m, sand with clay, brown  
C) 1.2m to 1.7m, oxidized, clay-chlorite altered andesite porphyry (pebble to cobble size) (MGB XI, 2018)

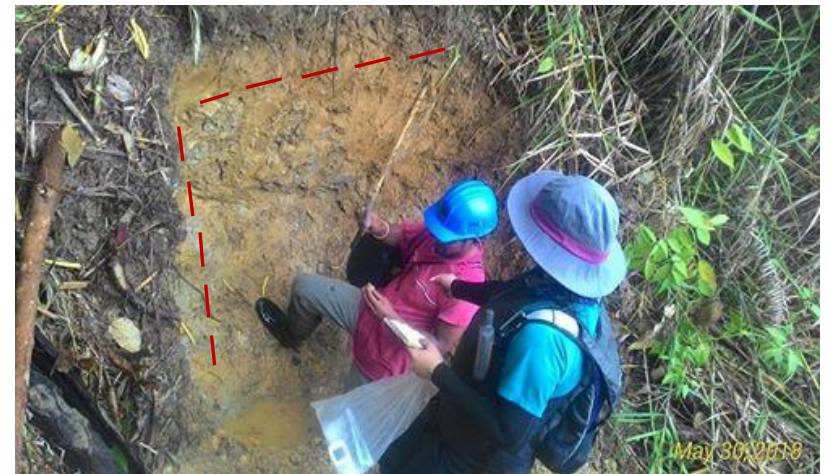
Figure 8. A) Red lines showing dimensions: Width- 1.2m, Length- 1m, Height- 0.7m to 1.2m  
B) Inclined along moderately steep slope about 0.7m clayey soil capping the moderate to highly weathered and clay altered andesite porphyry (MGB XI, 2018)
